**MULTI-MEDIA COMPLIANCE EVALUATION INSPECTION
U.S. ENVIRONMENTAL PROTECTION AGENCY
REGION III
OFFICE OF ENFORCEMENT, COMPLIANCE, & ENVIRONMENTAL JUSTICE**

**American Zinc Recycling Corporation
(formerly Horsehead Corporation)
900 Delaware Ave
Palmerton, Pennsylvania 18071**

Inspection Dates: 14-18 May 2018

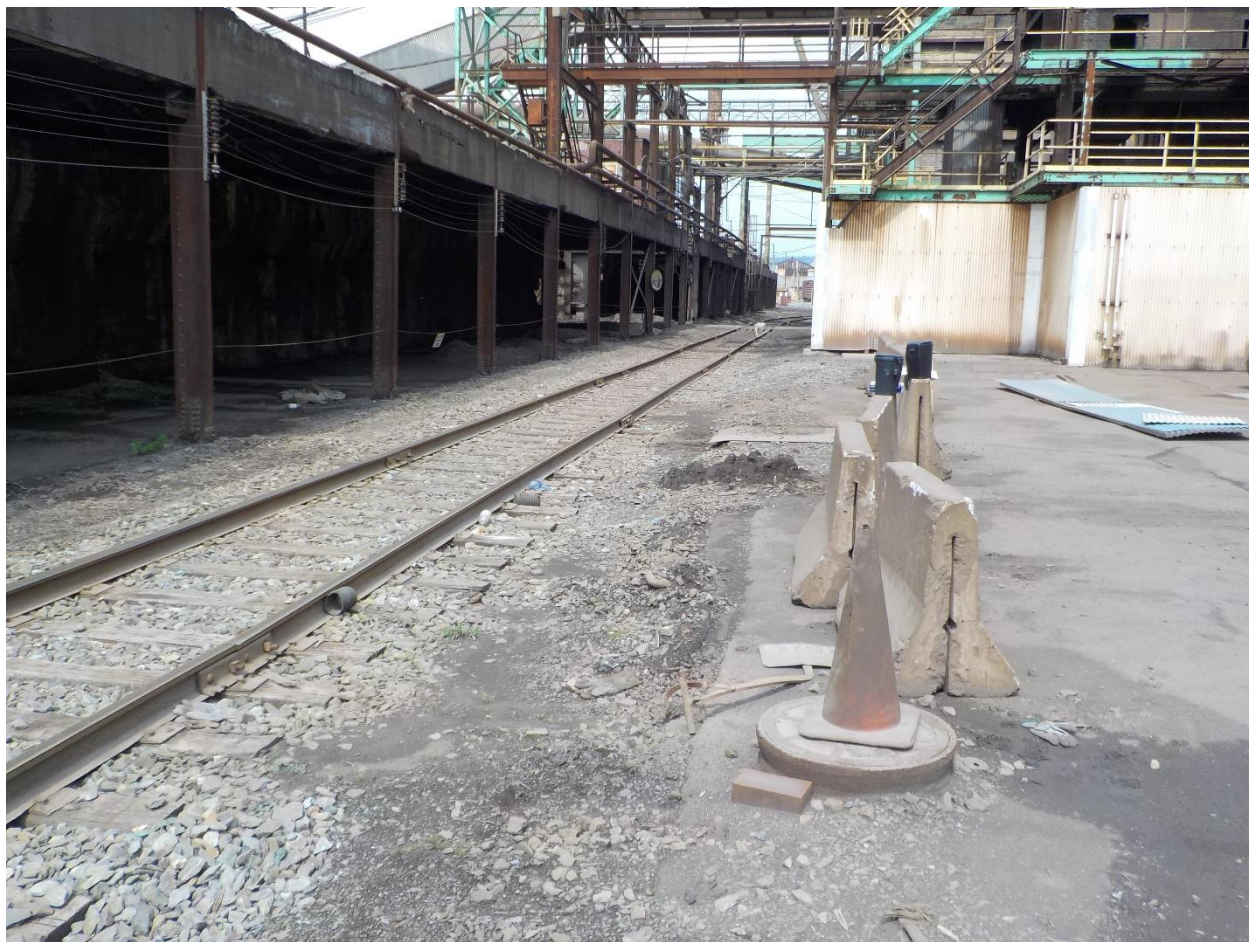
Approximately 10 meters (30 feet) west of sump “11,” EPA inspectors Trakis, Kline, and Eller observed the second feature not shown on the outfall and drainage map, a manhole. EPA inspectors designated the manhole as feature “10.” The manhole was marked with a traffic cone (see Photo 110). Mr. Falko stated he did not know if manhole “10” was connected to the Facility’s storm sewer or industrial wastewater system. It is unclear to the EPA inspectors whether manhole “10” is connected to the Facility’s industrial wastewater system, storm sewer system, or sanitary sewer system.

Photo 110. (DSCN0265) This photo looks eastward down the railroad bed immediately north of the kilns. In the foreground, the feature designated “manhole 10” by EPA inspectors, is visible with a traffic cone on top.

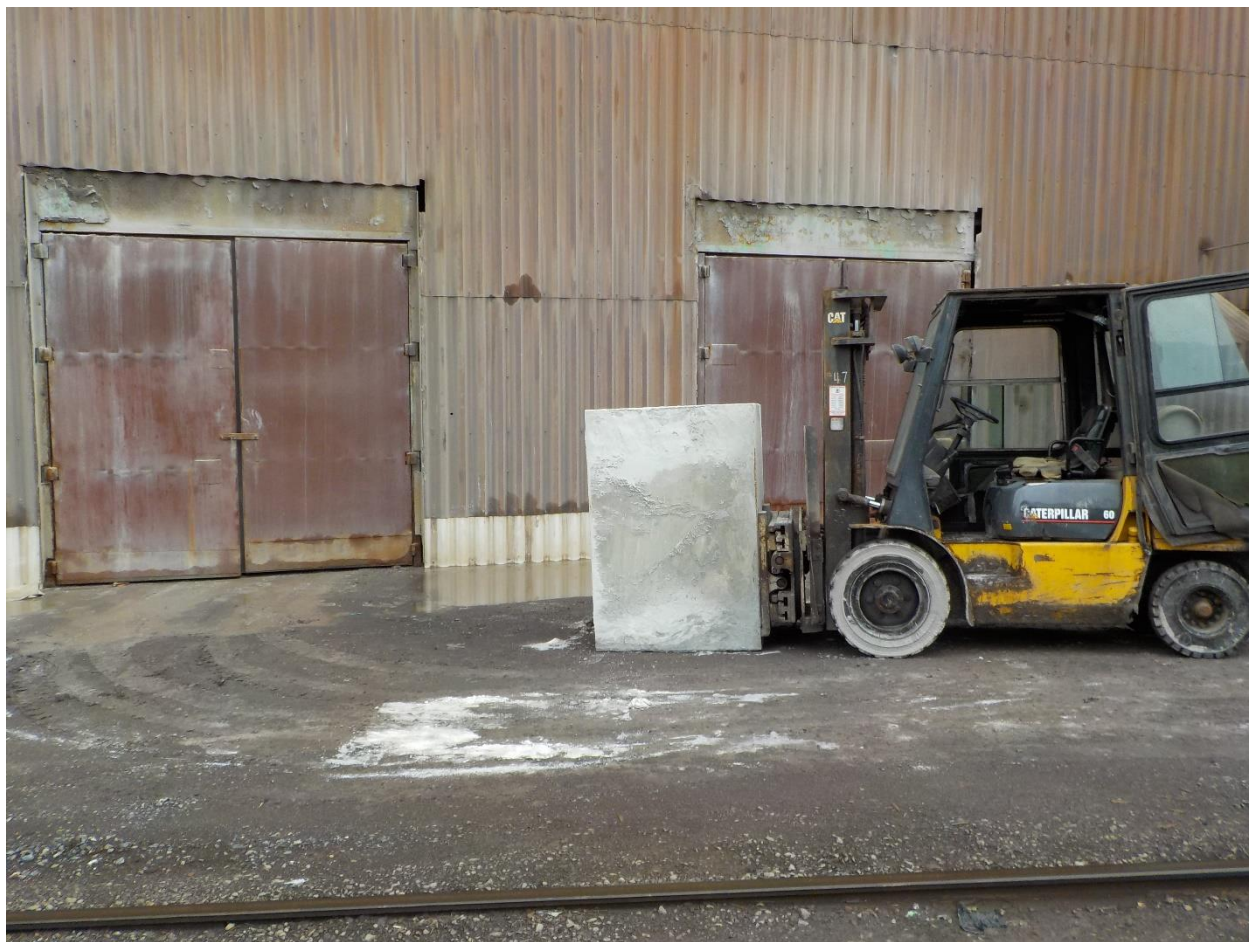
At approximately 10:17 on 17 May, 2018, EPA inspectors Kline and Eller observed the Kiln 1 baghouse (“product collector”). EPA inspectors Eller and Kline observed a white, granular material on the ground near the baghouse. EPA inspector Eller inquired about the material and Mr. Falko stated it was lead chloride. Eller asked where the lead chloride has come from, and Mr. Falko explained there had been a lead chloride release within the last 24 hours (See Photos 111 and 112).

Photo 111. (DSCN0370) This photo shows part of the southern side of the Kiln 1 “product collector” (baghouse). Note, the white, granular material present on the ground is lead chloride that was released sometime between 16:00 on 16 May, 2018 and 10:17 on 17 May, 2018.

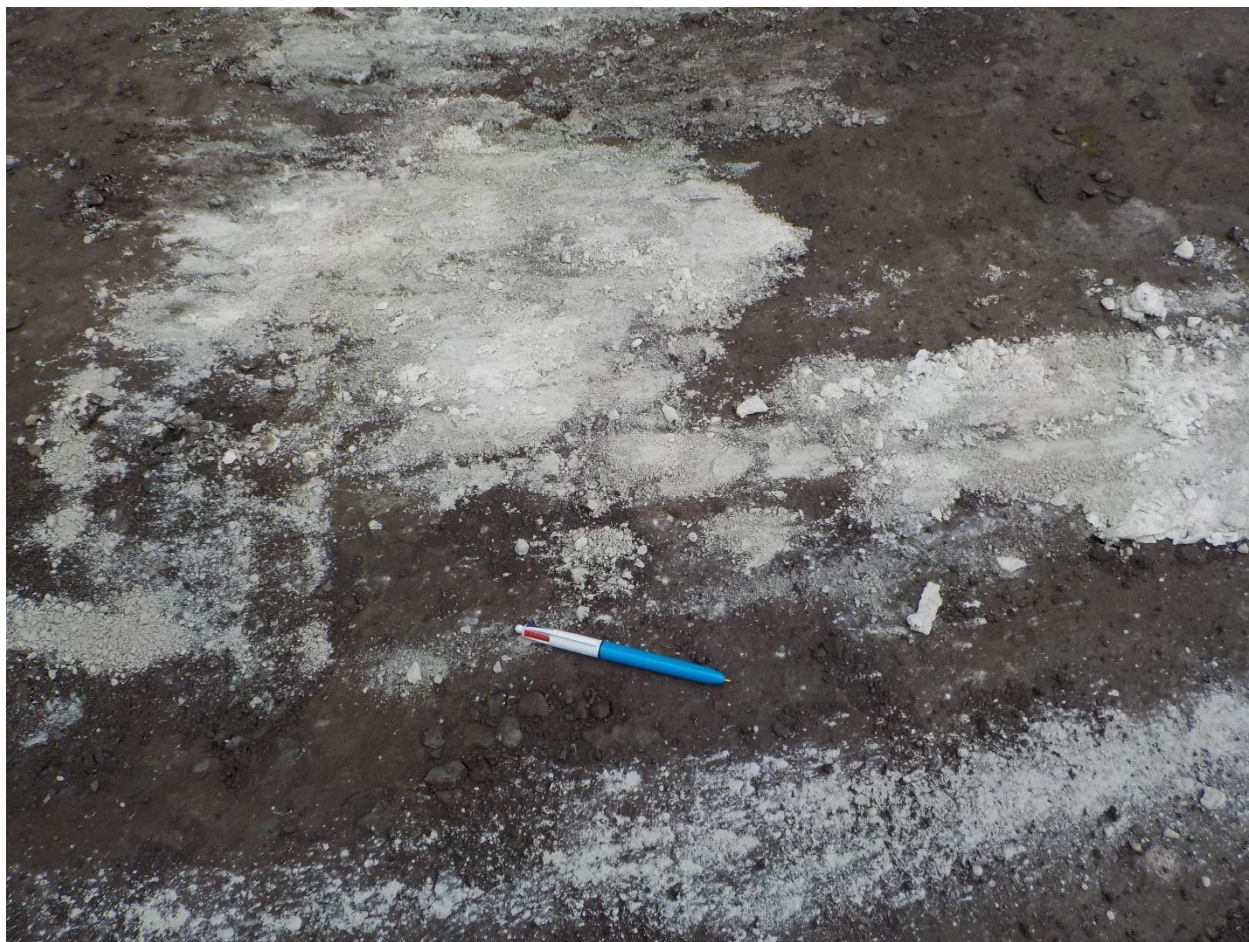
Photo 112. (DSCN0376) This photo shows a close-up of lead chloride released from the Kiln 1 product collector (baghouse). The pen placed for scale is 5.5 inches.

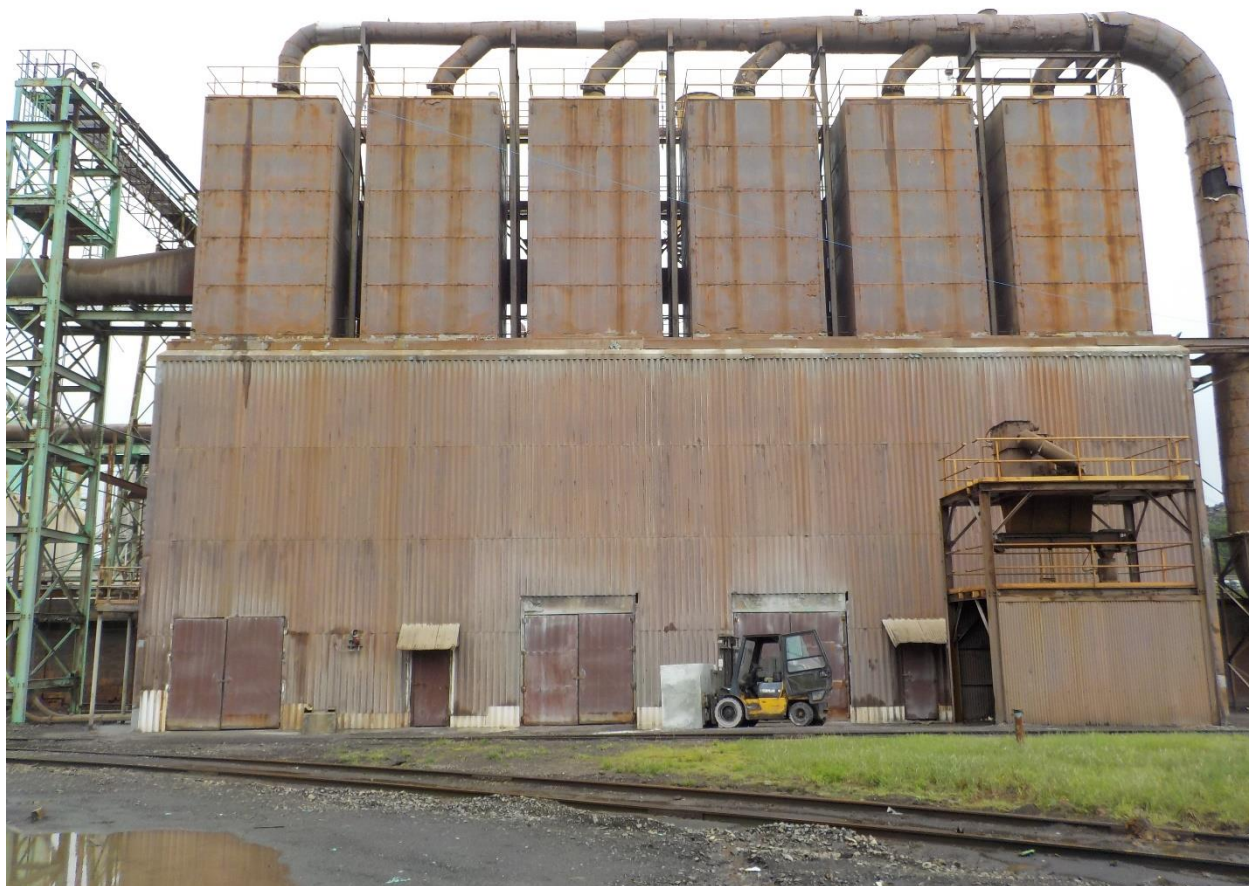
Photo 113. (DSCN0377). This photo shows the baghouse (termed a “product collector” by the Facility) that collects lead chloride (PbCl_2) volatilized by the calcining process in Kiln 1. The pipeline from the dust catcher is visible entering the baghouse at top left. The six baghouses are situated in the middle. At far right is the main pipe leading to the stack (stack not visible in this photo). See also Photo 114.

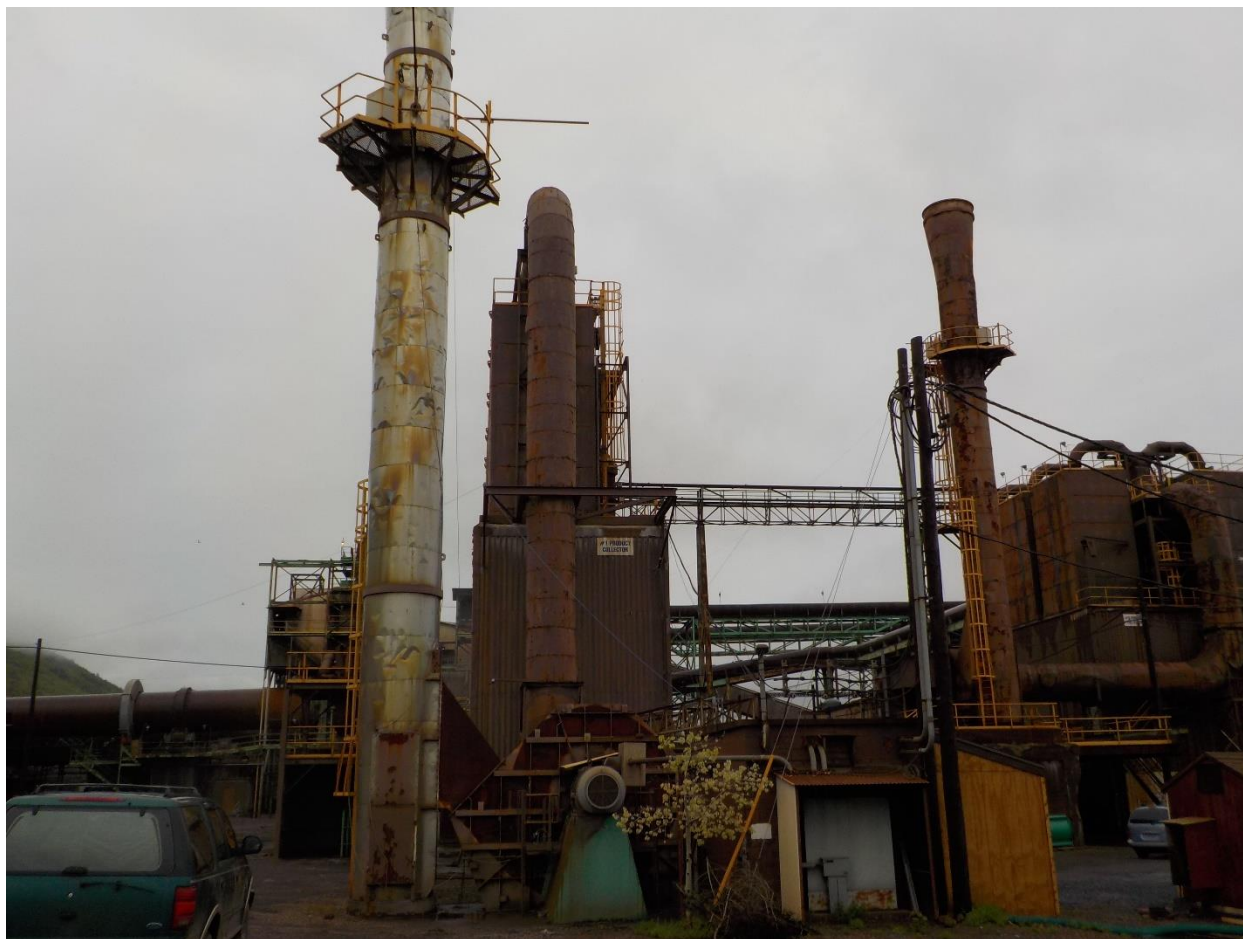
Photo 114. (DSCN0368) This photo looks westward towards the baghouse (termed a “product collector” by the Facility) and stack for Kiln 1 (at left) and the baghouse and stack for Kiln 6 (right). A portion of rotary Kiln 6 is visible at far left in the background.

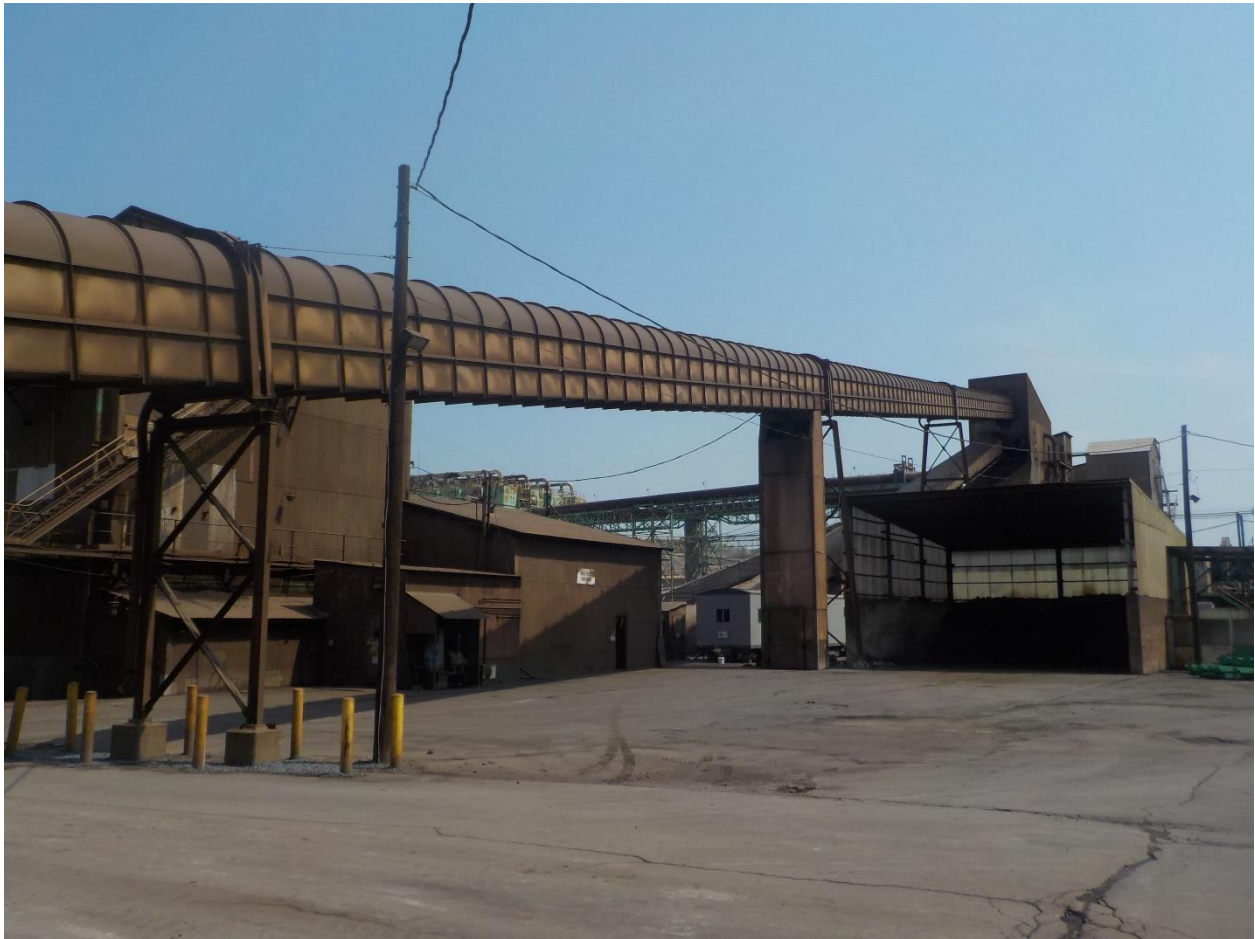
Photo 115. (DSCN0201) This photo looks east-northeast at the elevated conveyor belt, for pelletized EAF dust and coke, called the “Blender bypass.”

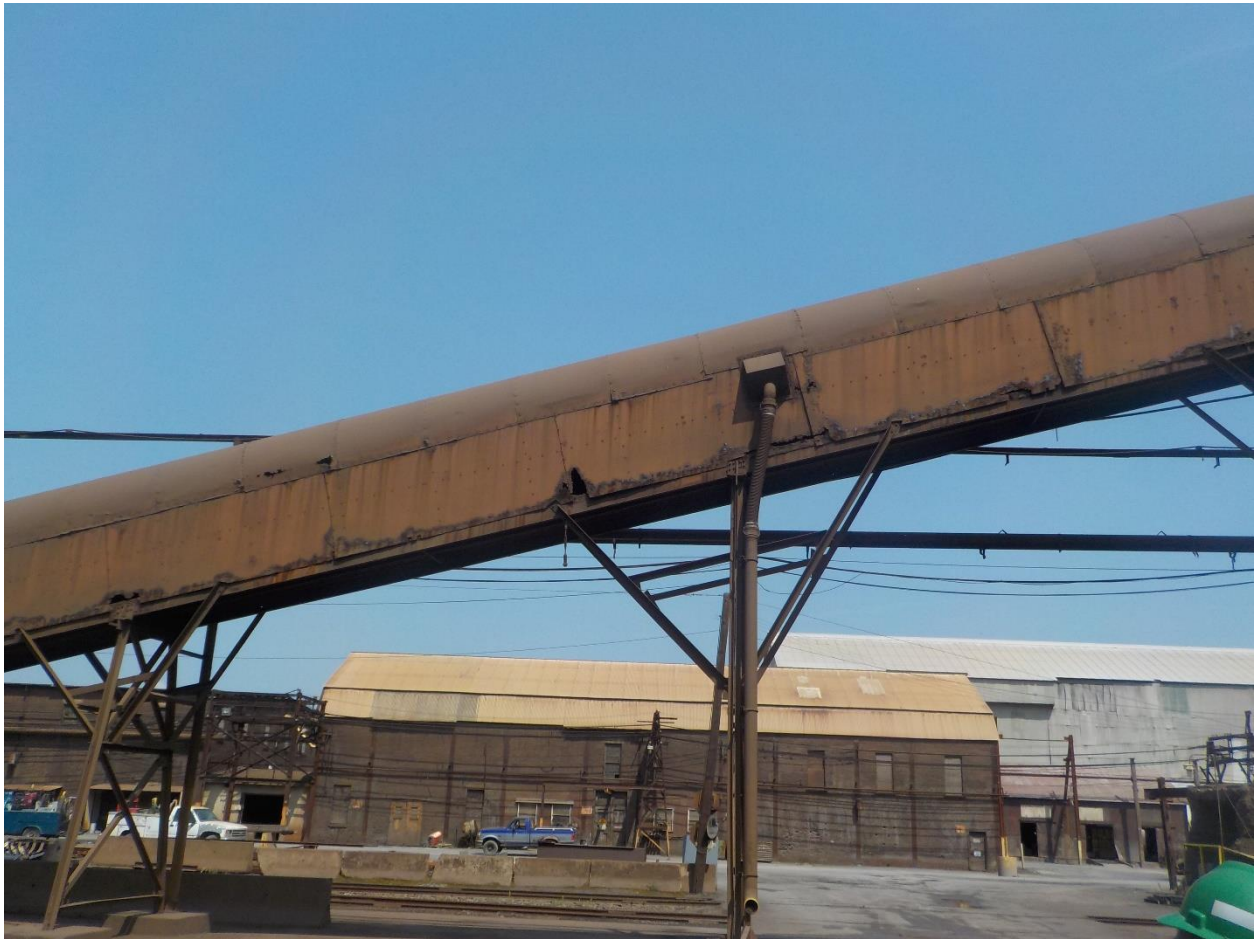
Photo 116. (DSCN0204) This photo looks northward at a portion of the elevated conveyor belt, for pelletized EAF dust and coke, called the “gallery belt.” Note, there appear to be holes or gaps in the metal on side of the “gallery belt.”

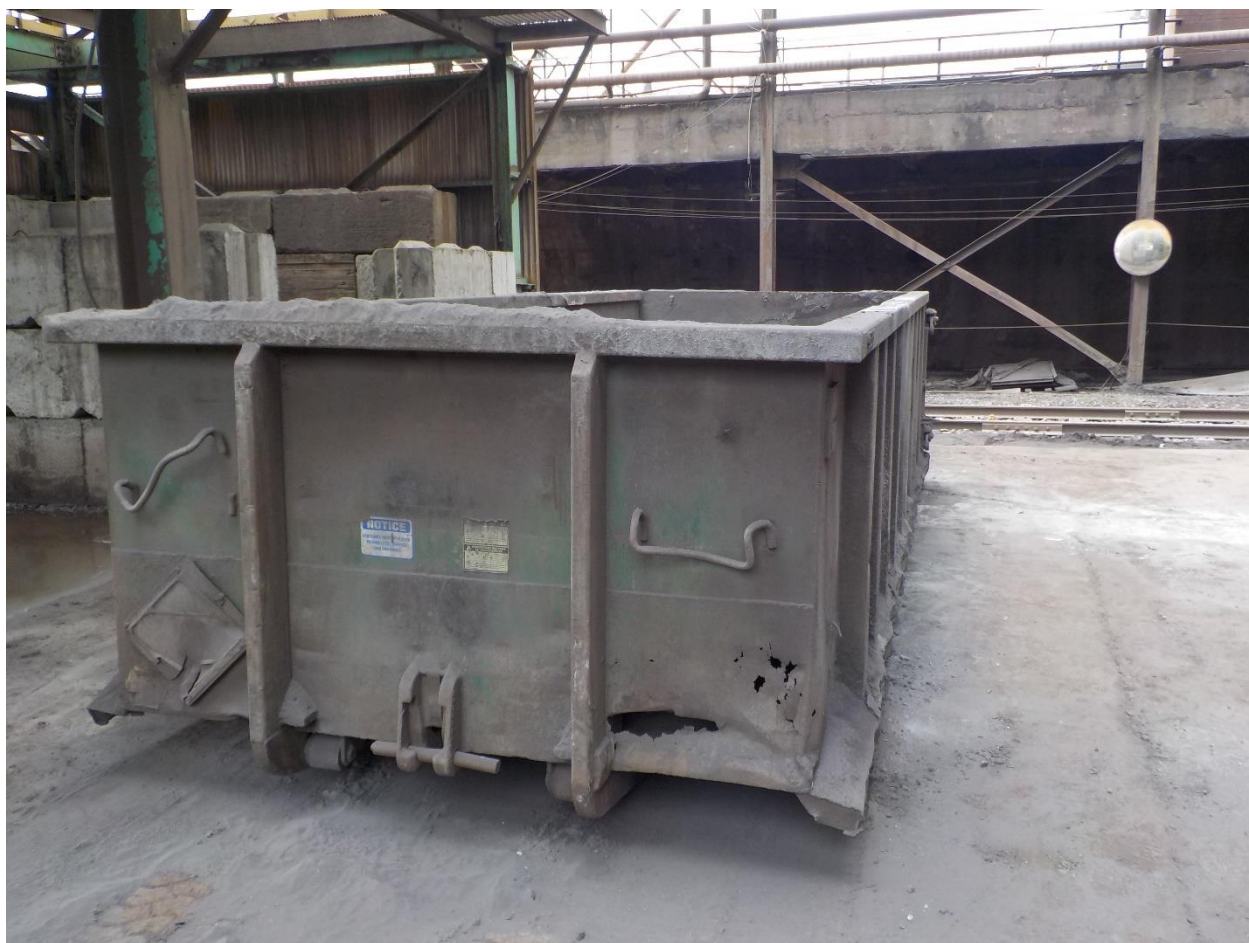
Photo 117. (DSCN0277) This photo shows a roll-off dumpster situated between Kiln 2 and former Kiln 3. See also Photo 118.

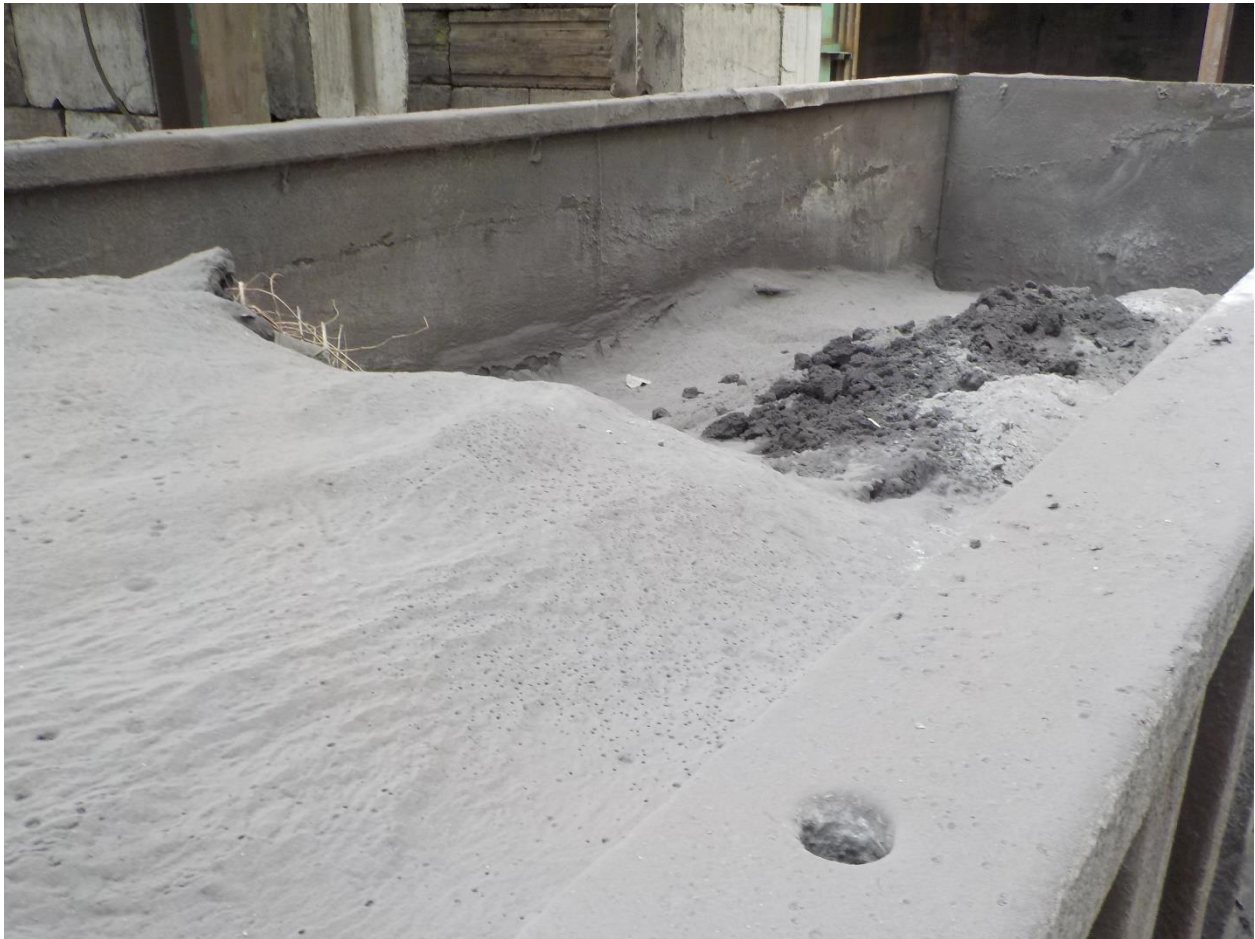
Photo 118. (DSCN0278) This photo shows a close-up view of part of the interior of the roll-off dumpster observed between Kiln 2 and former Kiln 3 (see Photo 117). The dumpster contains a gray, fine-grained material, as well as some black granular material on top.

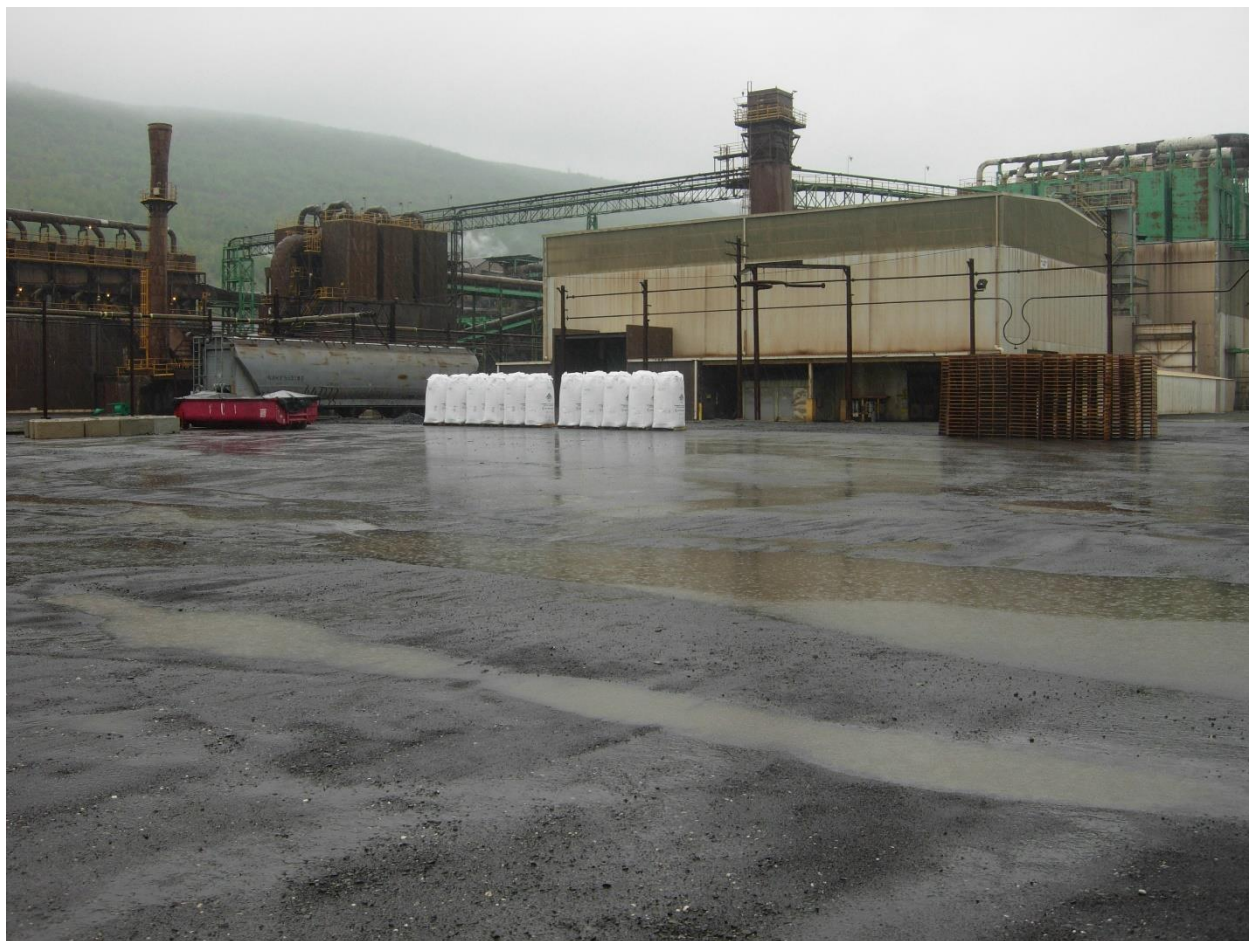
Photo 119. (DSCN0281; NIKON COOLPIX P4) This photo looks southwest towards the Kiln 1 and Kiln 6 baghouses (termed “product collectors” by the Facility). The eleven (11) white supersacks visible in this photo contain lead chloride, according to Mr. Falko. See also Photo 120.

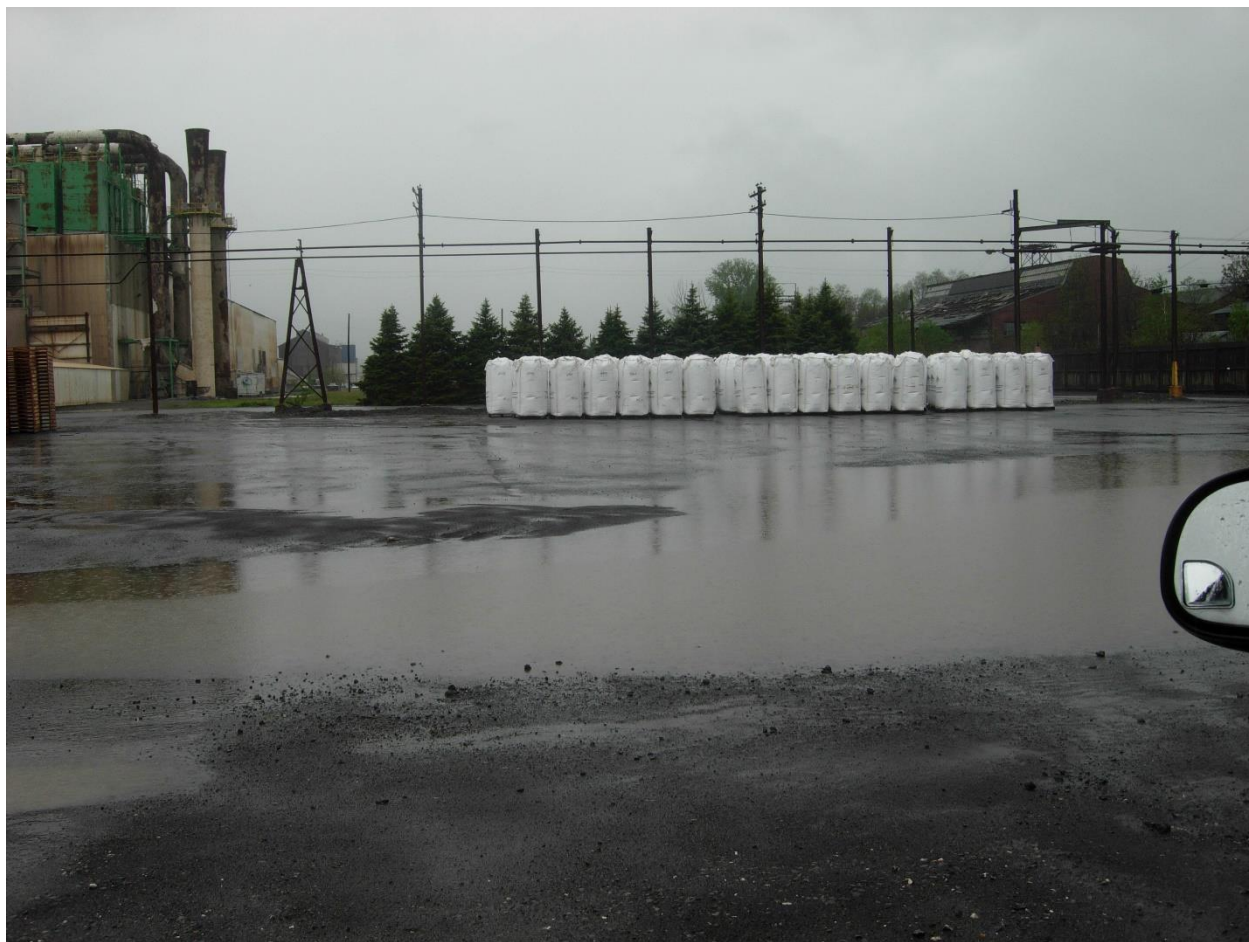
Photo 120. (DSCN0283; NIKON COOLPIX P4) This photo shows supersacks of lead chloride stored outdoors on wooden pallets. Part of the Kiln 6 baghouse (“product collector”) is visible at far left in this photo.

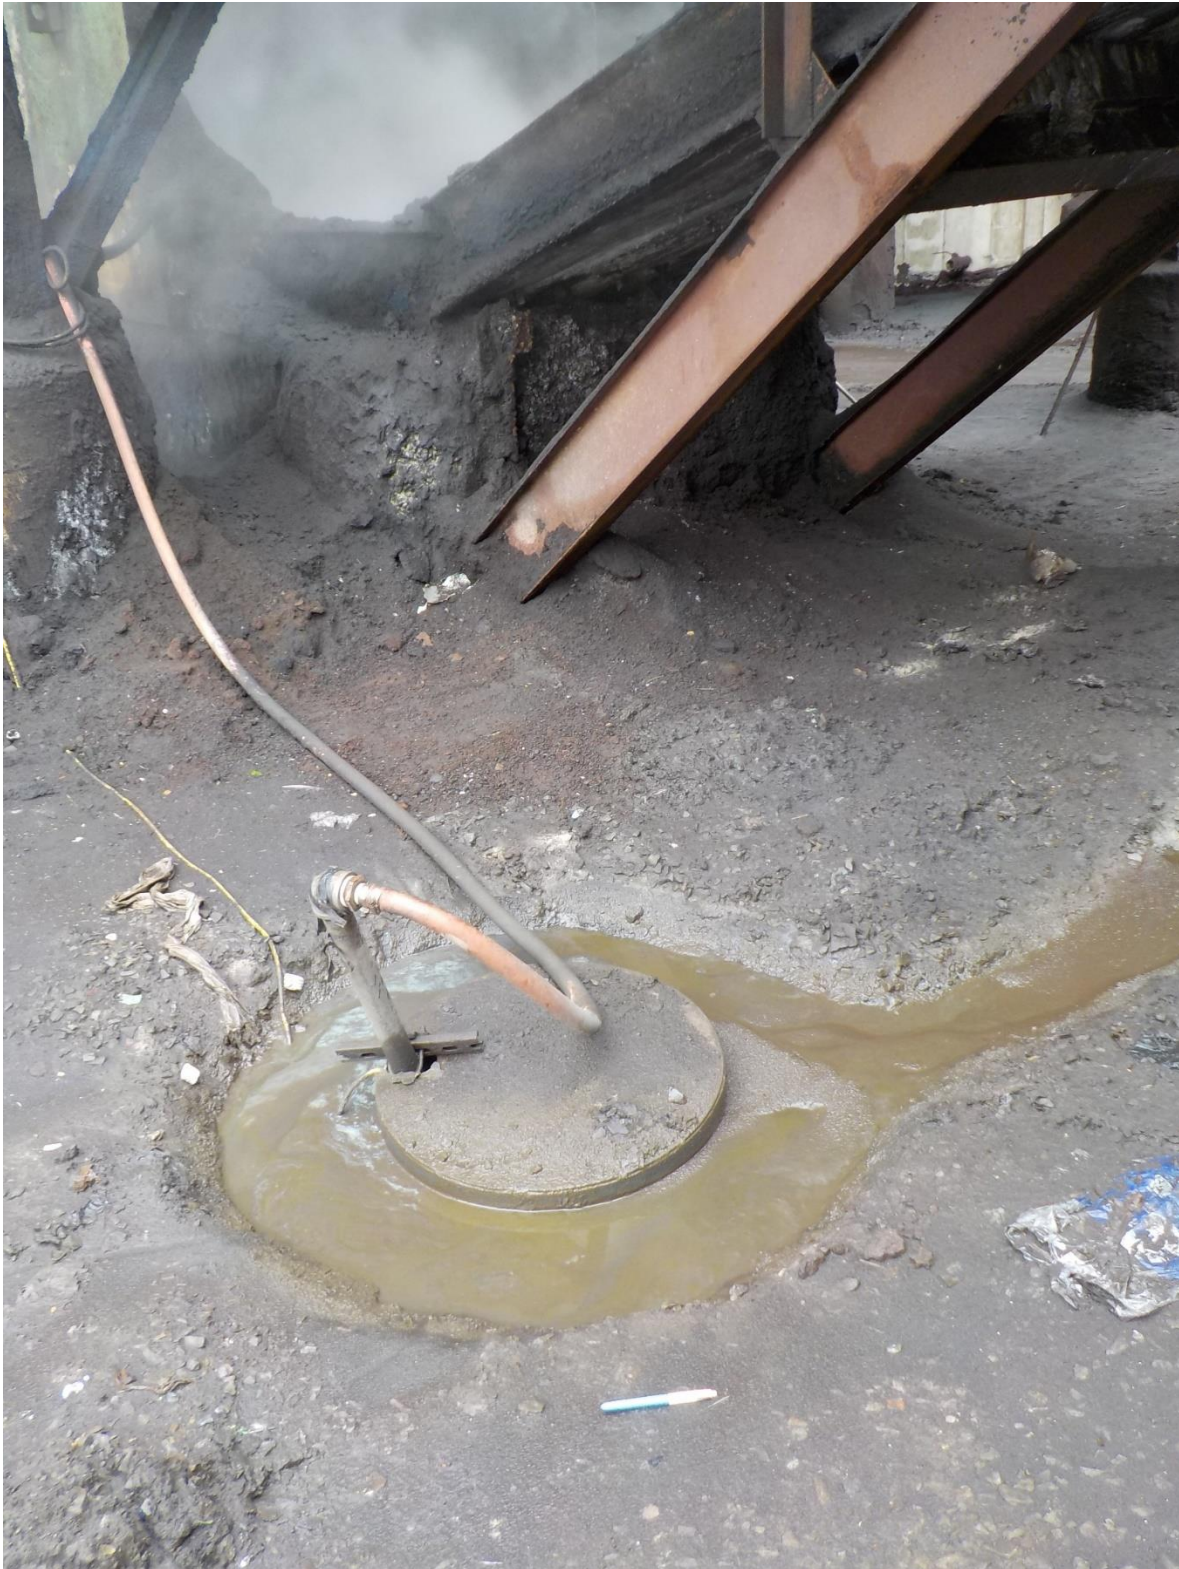
Photo 123. (DSCN0367) This photo shows the quench water sump near the Kiln 2 quench tank, where EPA inspectors collected grab samples for field pH measurement and total metals analysis. A 5.5-inch pen is shown for scale. See also Photos 121 and 122.

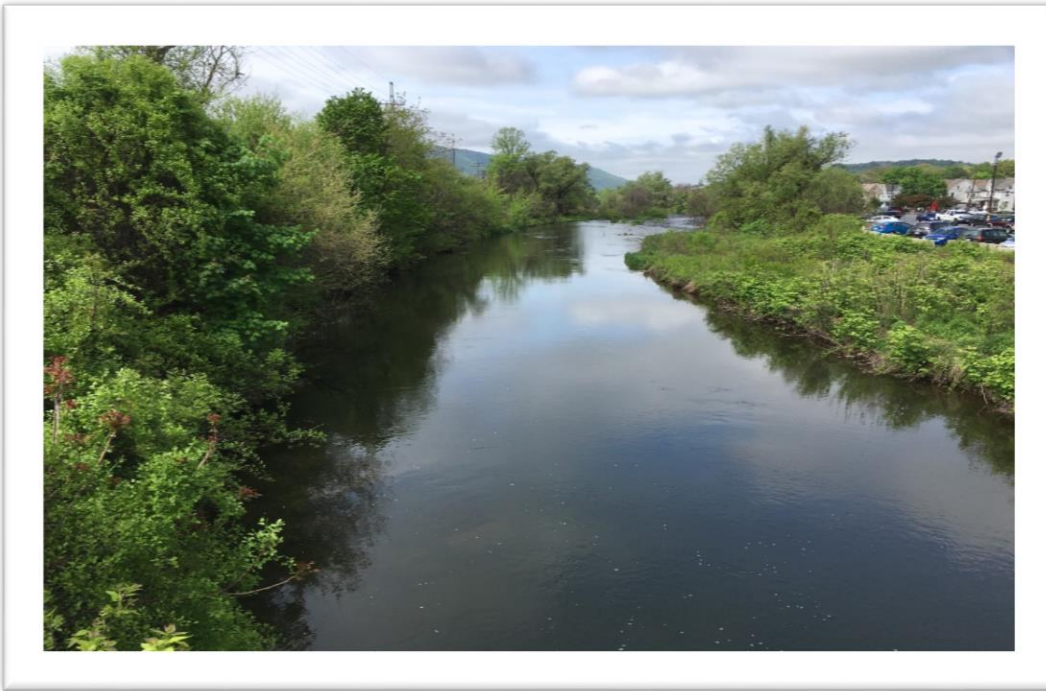
Photo 124. (IMG_0322.JPG): View of the Aquashicola Creek from the bridge at the main entrance to the Facility

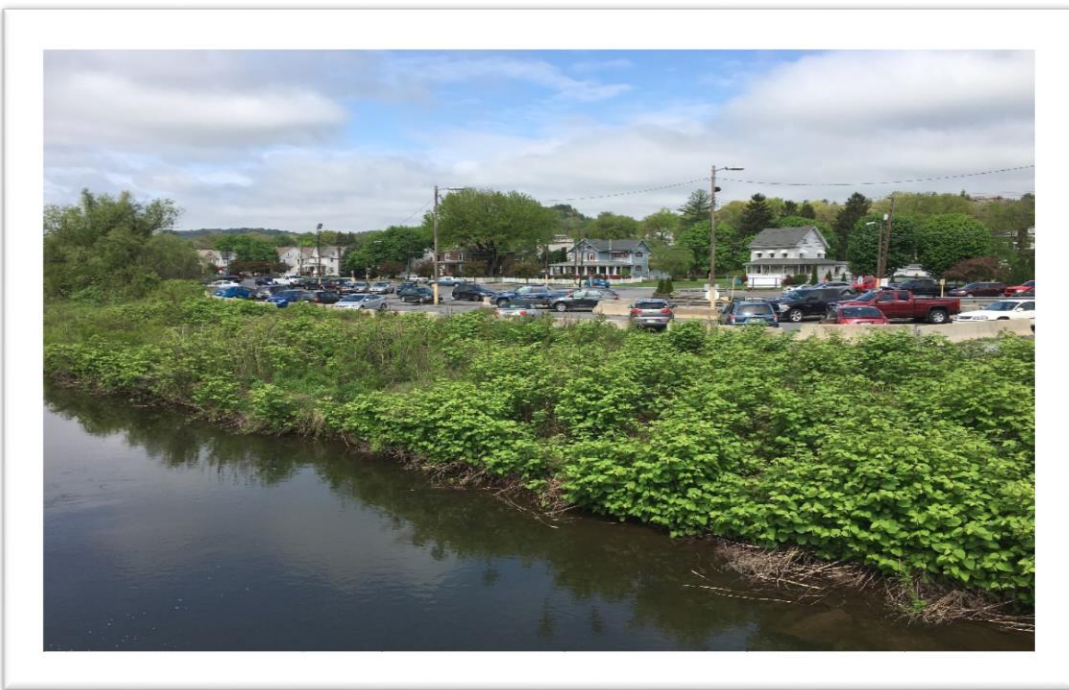
Photo 125. (IMG_0323.JPG): View of the Aquashicola Creek and the Facility parking lot from the bridge at the Facility's main entrance.

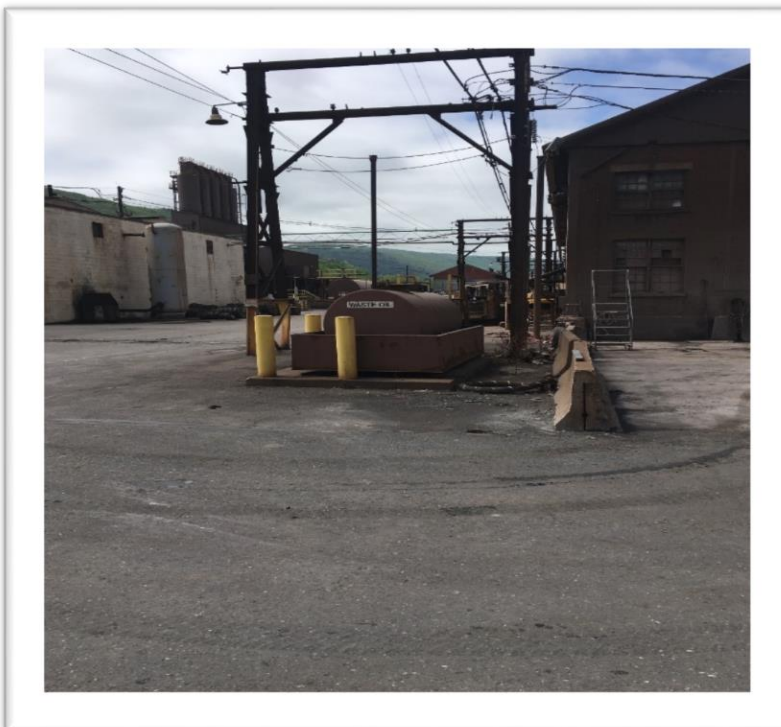
The Waste Oil Tank, a 1,000-gallon AST, was visited by EPA inspectors Jiménez and Hernández-Vega (see Photo 126). The AST was inside of a metal structure that serves as secondary containment. Based on the ICP, the secondary containment capacity is 1,167 gallons. At the time of the Inspection, around two inches of water were measured inside the secondary containment. The Facility and surrounding area experienced rain days before the Inspection (see Table 1).

Photo 126. (IMG_0329.JPG): View of the 1,000-gallon waste oil AST.

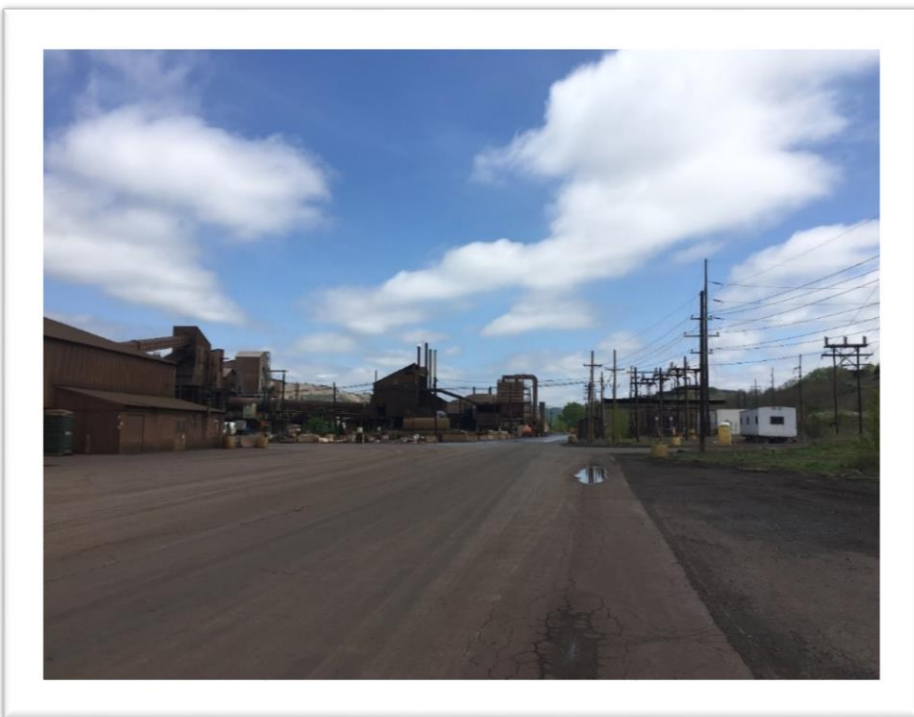
Photo 127 shows a view of AST Tank 001A (Fuel Oil) and Electrical Substation No. 40. Three oil-filled transformers were in this substation (see Photos 128, 129 and 130). The substation was closed, and Jiménez and Hernández-Vega were not able to see the nameplates. Transformer No. 5 had a blue sticker indicating Non- PCBs (see Photo 130). At Electrical Substation 42, EPA inspectors Jiménez and Hernández-Vega observed combustible materials (e.g., wood pieces) at the substation. No sign of leak was observed at the time of the Inspection.

Photo 127. (IMG_0332.JPG): View of Electrical Substation No. 40 on the right and 20,000-gallon Fuel Tank on the left.

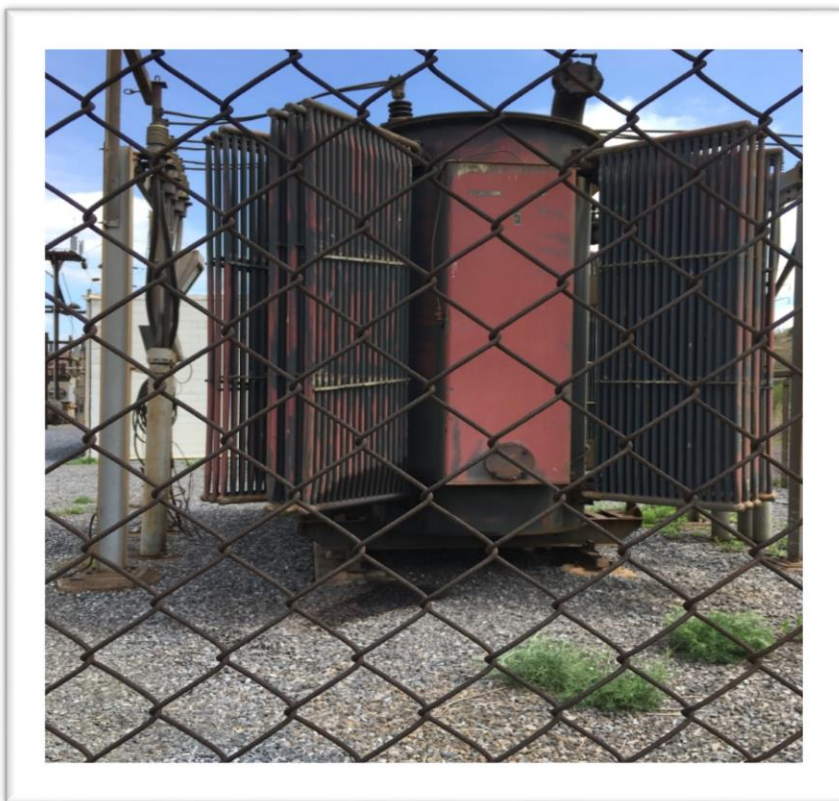
Photo 128. (IMG_0347.JPG): View of Transformer No. 5 at Electrical Substation No. 40.

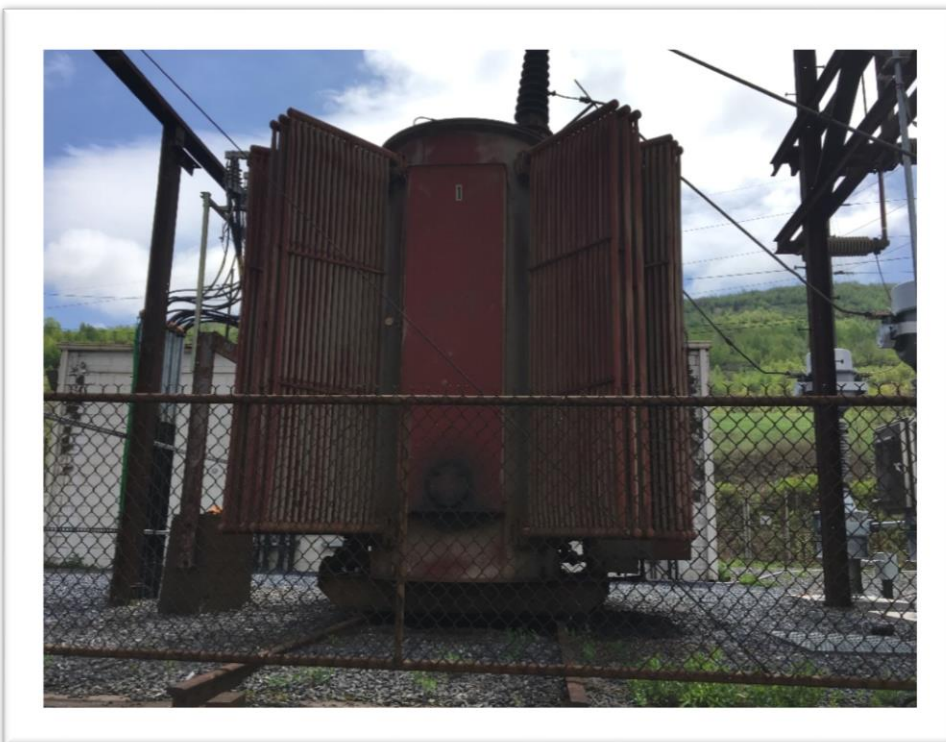
Photo 129. (IMG_0348.JPG): Oil-filled Transformer No. 1 at E.S. No. 40.

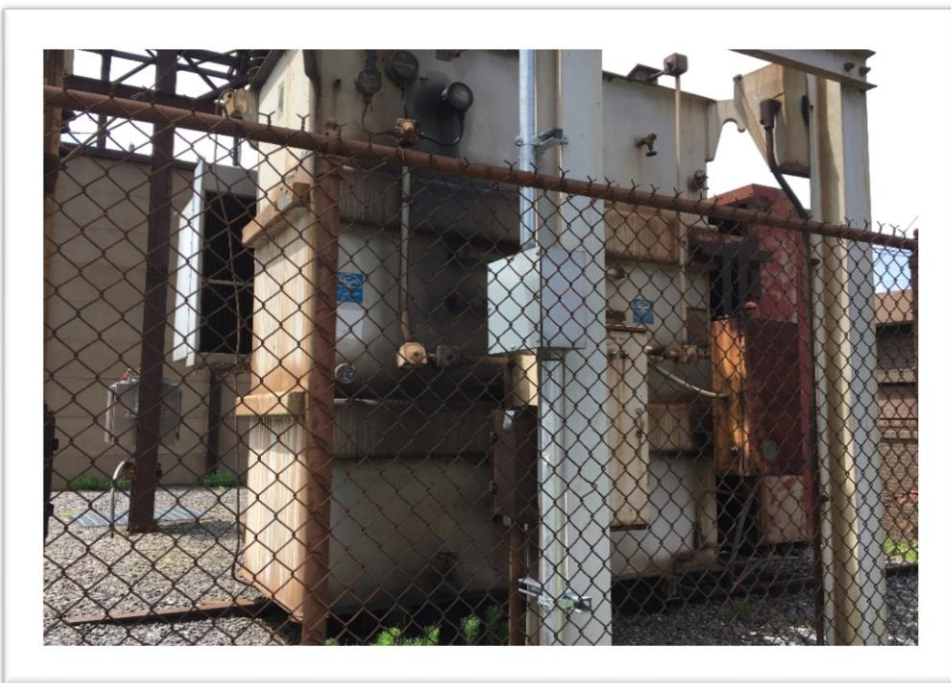
Photo 130. (IMG_0351.JPG): Oil-filled Transformer with Blue Stickers indicating Non -PCB.

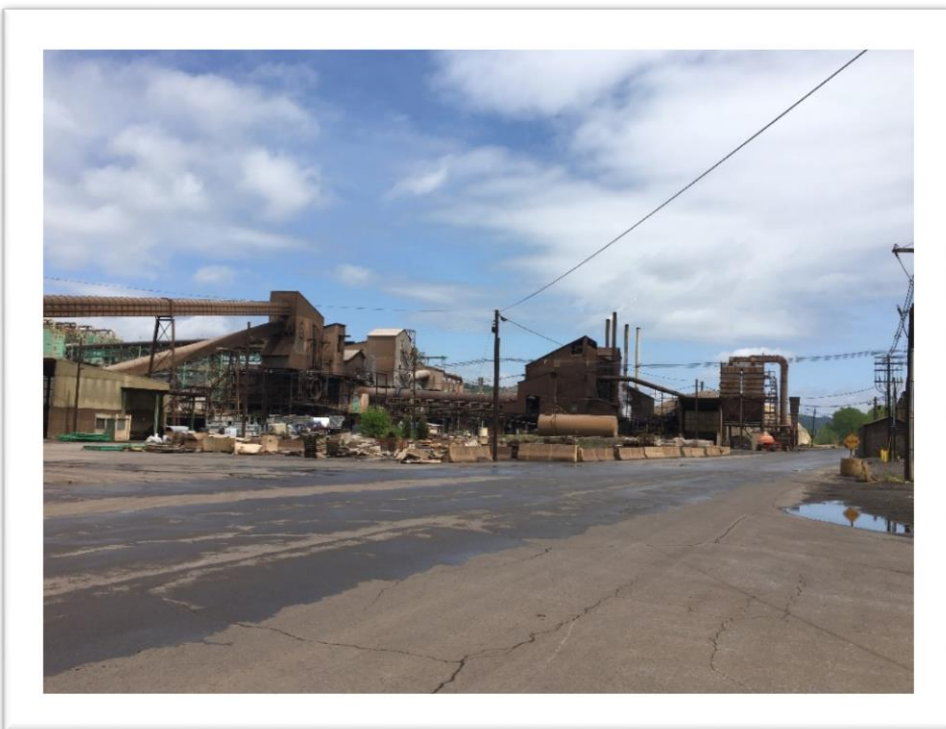
Tank No. 002A is a 20,000-gallon fuel oil tank, see Photos 131 and 132. At the time of the Inspection, the diked area was free of vegetation, dry and in good shape. Based on the ICP, the secondary containment capacity is 47,759 gallons and the dike is made of clay. An open pipe (no cap or valve to control flow of fluid on both sides) was observed through the berm, see Photos 133 and 134. Another pipe, this one connected to the AST, and passing on top of the diked area, was supported by a piece of wood (see Photo 135).

Photo 131. (IMG_0352.JPG): View of Tank No. 002A a 20,000-gallon Fuel Oil AST and the kilns.

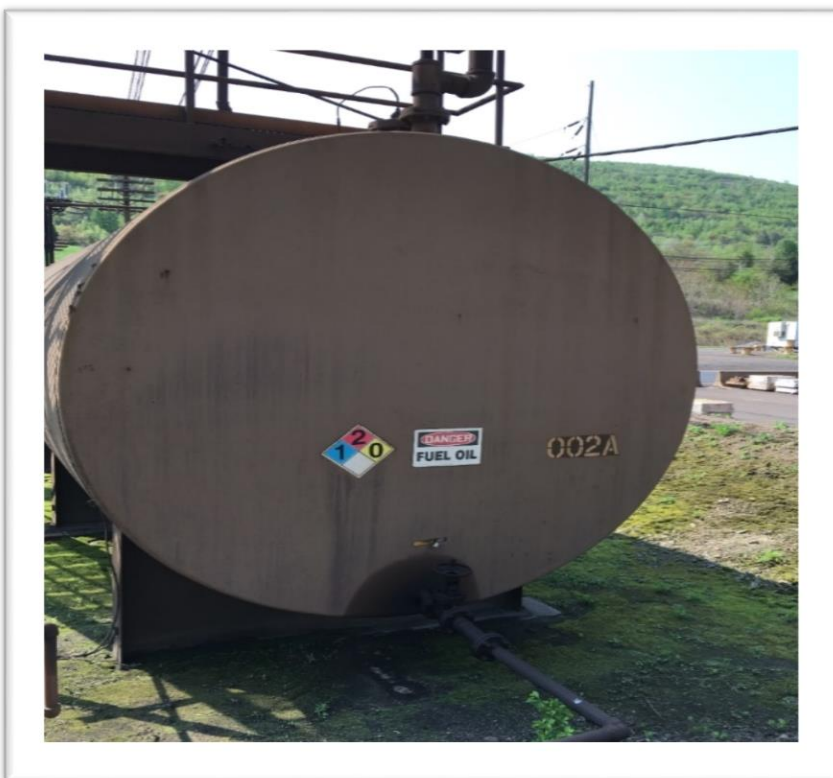
Photo 132. (IMG_0359.JPG): View of Tank No. 002A, a 20,000-gallon Fuel Oil AST.
